1743 Pelham Town Hall / Meetinghouse Interior Preservation Project

Mark Almeda Architects, P.C.
1281 Washington Street
Walpole, Massachusetts 02081
508.668.6221

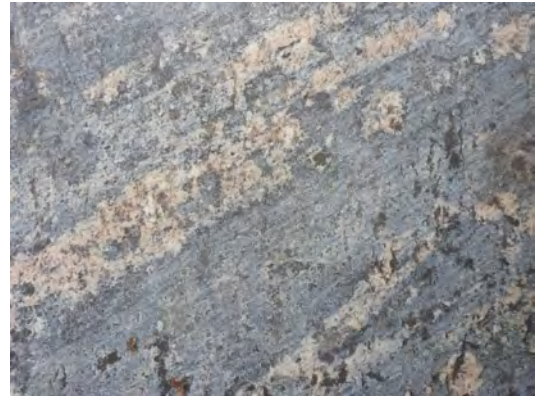
Fig. 3. Locally mined gneiss used for the foundation walls and door stoops.

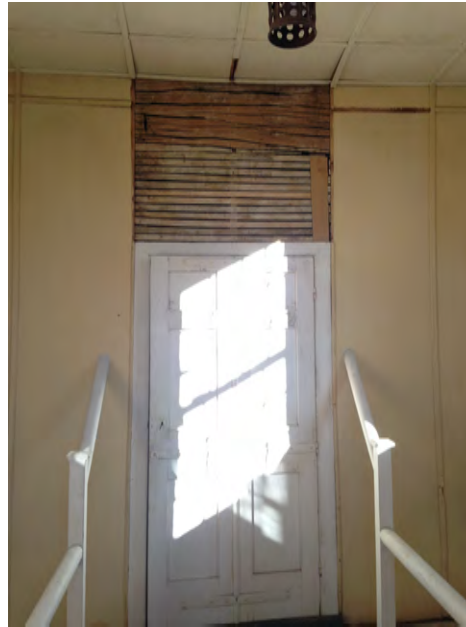
Fig. 10. Stair porch upper meeting hall entrance door. Fiberboard was removed and exposed the 1818 accordion wood lath above the c. 1845 machine sawn lath.

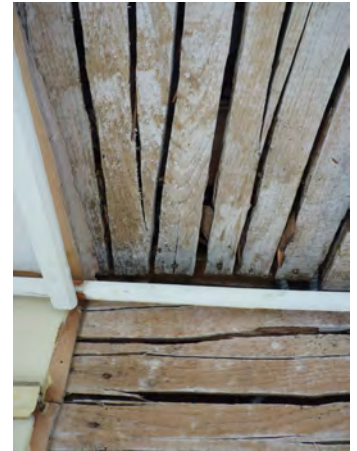
Fig. 11. Stair porch upper meeting hall ceiling and wall above entrance door. Both the ceiling and wall have accordion wood lath installed at the same time the 1818 stair porch was built and indicates plaster walls and ceiling.

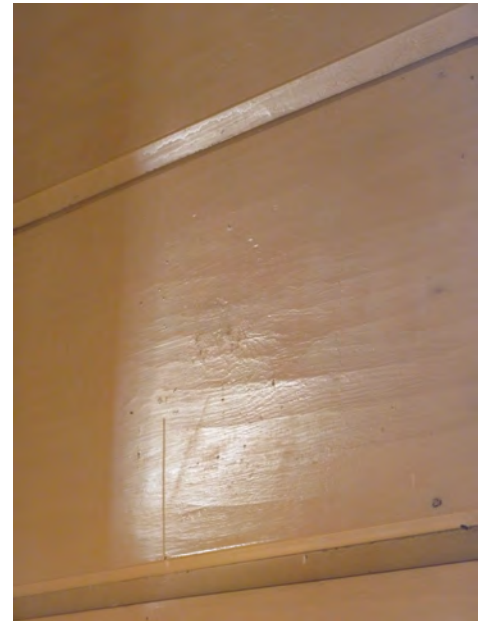
Fig. 12. 1773 hand planed feather edge wall paneling

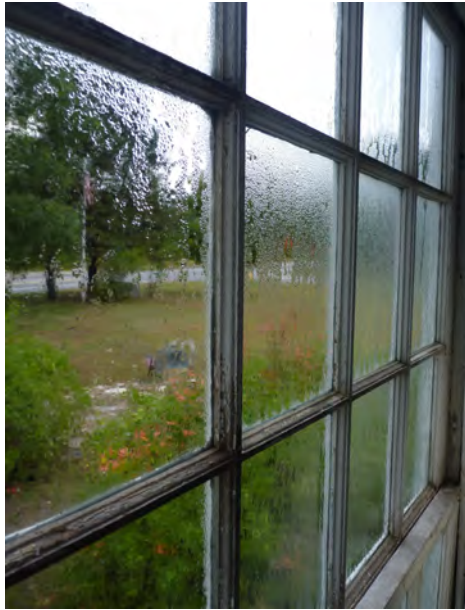
Fig. 13. Condensation forming on interior of 12/12 window causing failure of paint on muntins.

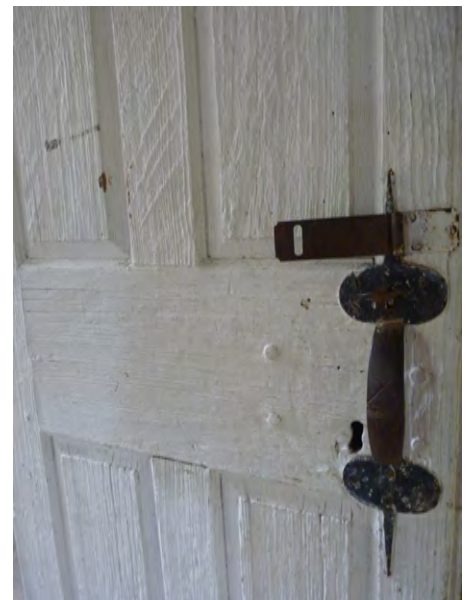
Fig. 14. Severely weathered interior lower meeting hall entrance door (repurposed pair) indicating its many years as an exterior door. Note the cleated Suffolk "bean" wrought iron thumb latch.

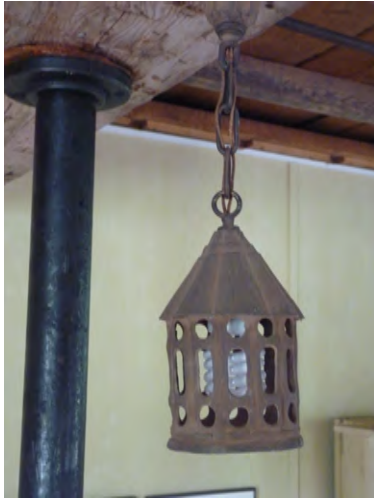
Fig. 15. Cast chain-hung fluorescent pendant

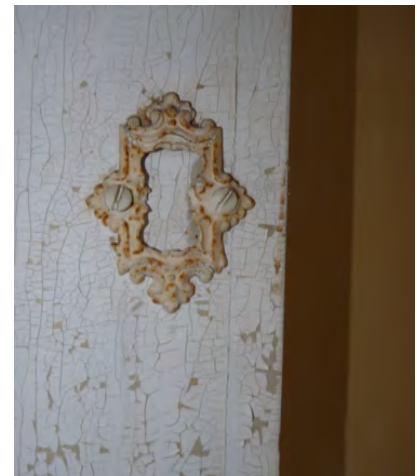
Fig. 17. Hinge remnant of wall mounted liquid fueled bracket lamp.

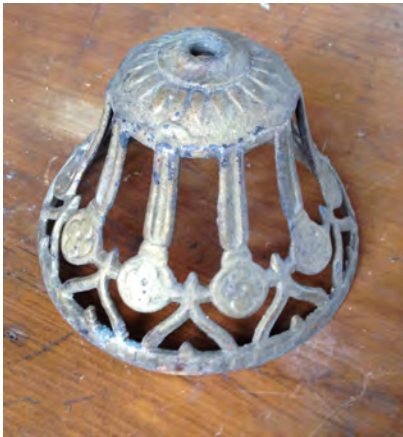
Fig. 18. Upside down bowl found under stage from liquid fueled lamp. This bowl held the glass liquid

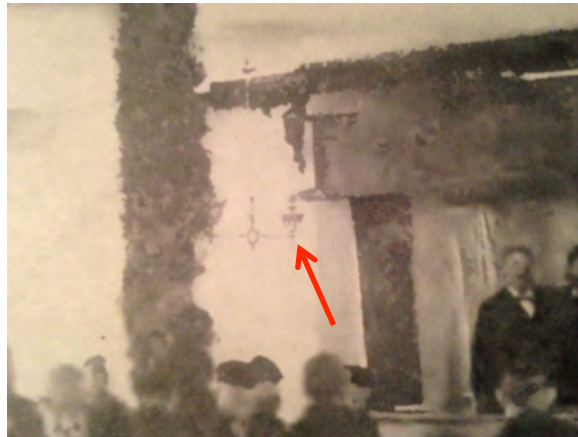
Fig. 19. Silhouette of liquid fueled chandelier photographed at 1897 town meeting. Image enlarged from Parmenter's History of Pelham, page 77.

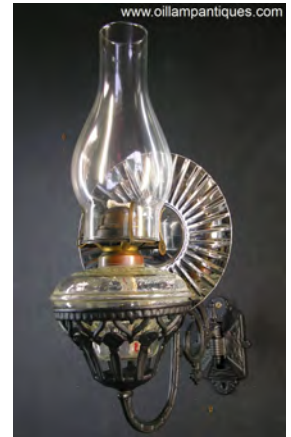
Fig. 20. Victorian era kerosene wall lamp showing what wall fixture would have looked like. Note bowl.

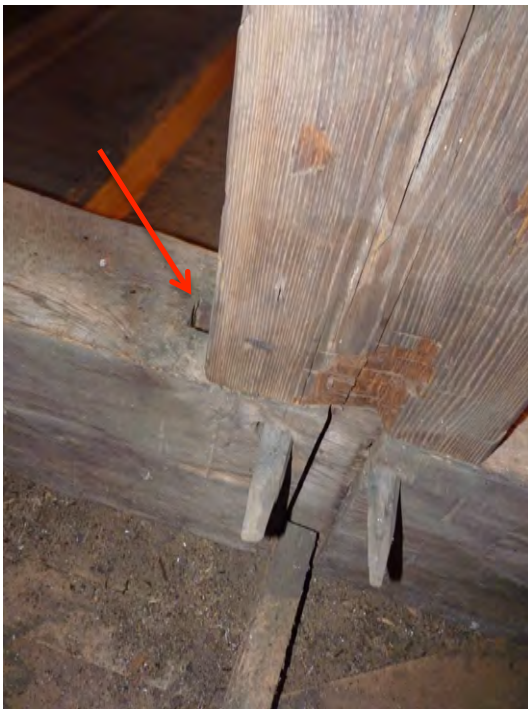
Fig. 22. King post mortised with interlocking tenon into bottom chord of truss. Notice pegs but missing wedge at left and sliding ceiling joist mortise joint.

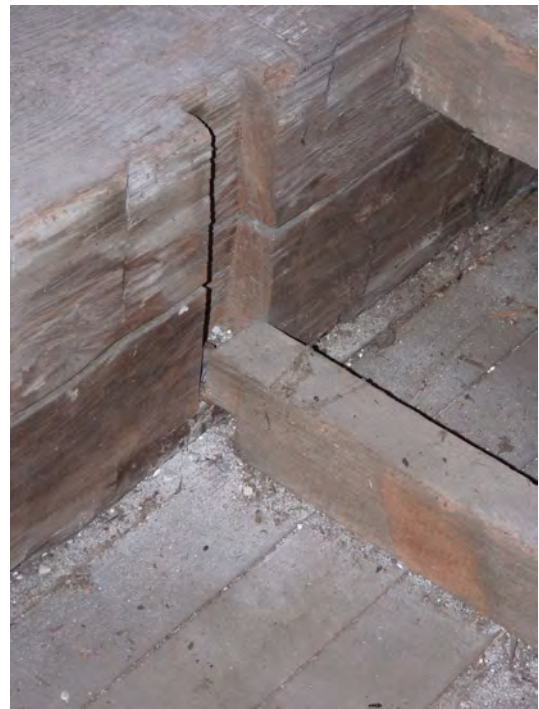
Fig. 23. Sliding mortise joint with ceiling joist almost completely out of the joint.

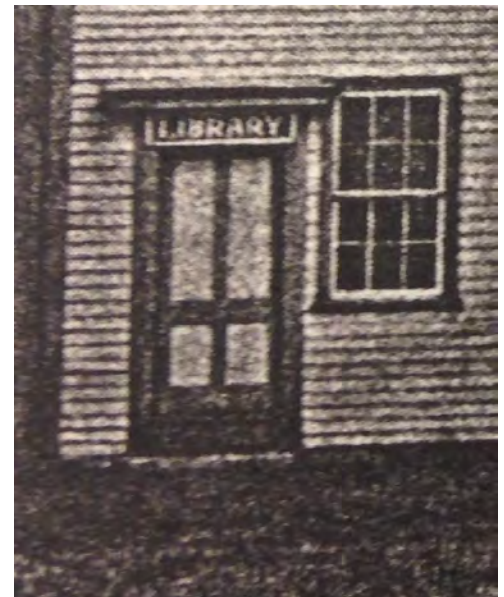
Fig. 24. Enlargement of library entrance from Figure 2 showing sign.

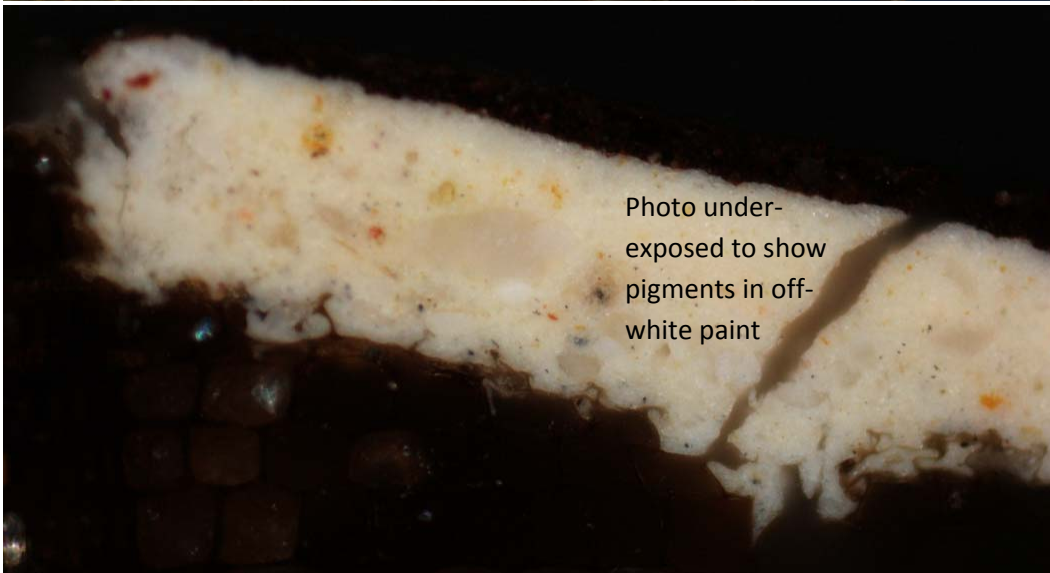
The thick off-white paint was applied to deteriorated or damaged wood.

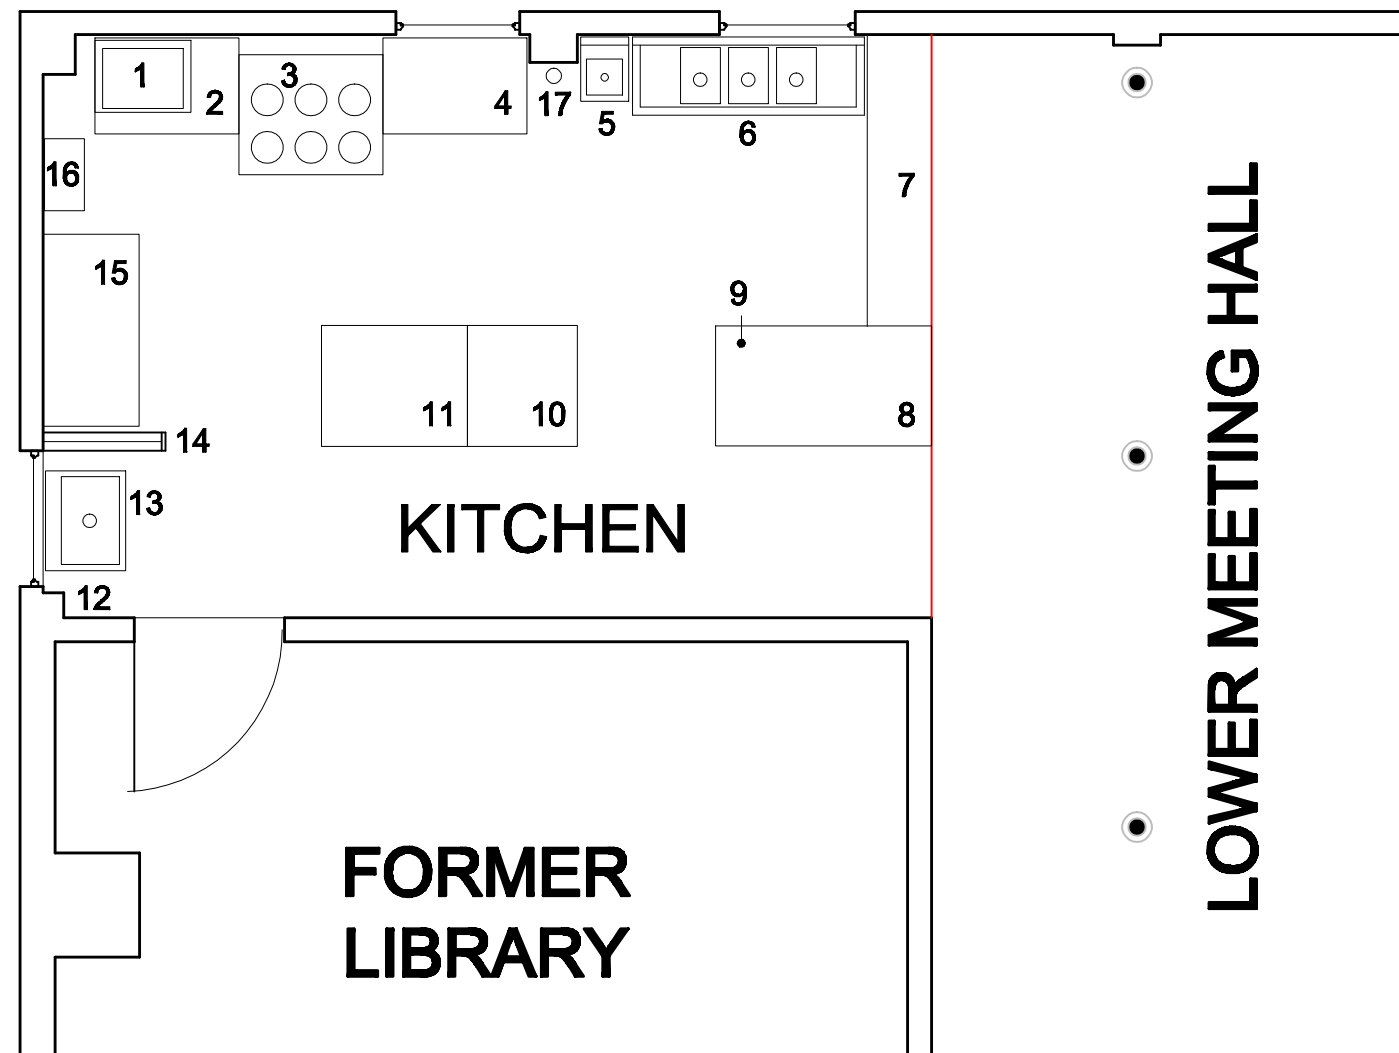
architecture@markalmeda.com
