**Pelham's Historic Town Center Buildings:
Study Reports**

Thomas Paske

This report was prepared for the Pelham Historical Society and the Pelham Historical Commission. The purpose of this survey is to describe the structures' present condition, locate damage and outline repair procedures.

April, 1991

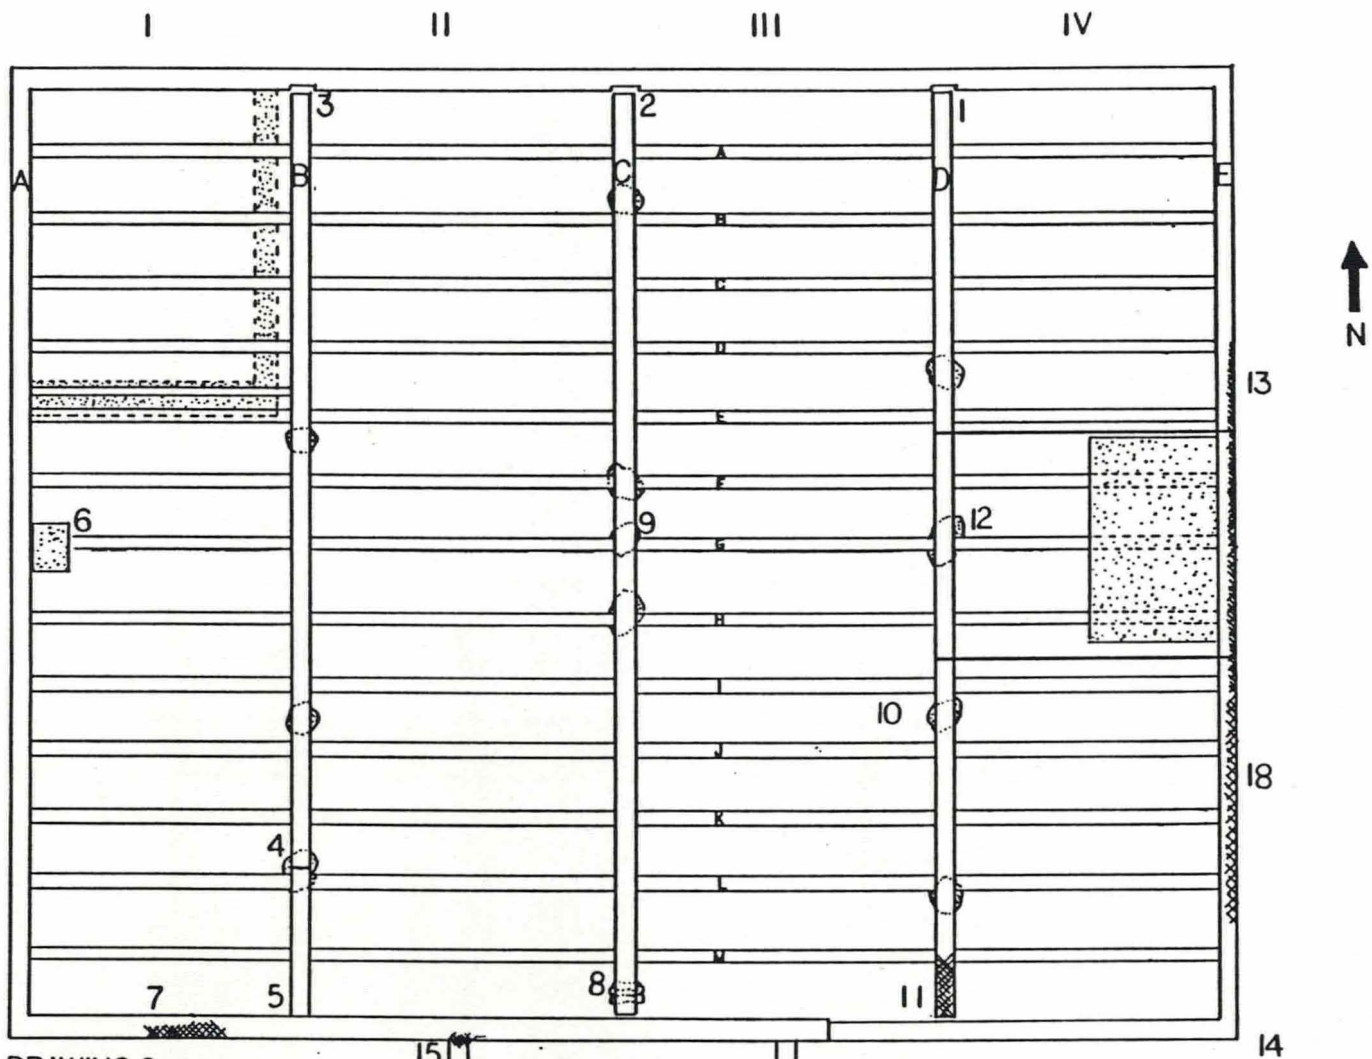
DRAWING 2.
 PELHAM MEETINGHOUSE
 FIRST FLOOR FRAMING PLAN

Because of the presence of periodic standing water the overall sound condition of the lower frame is surprising. Under these conditions timbers of this age usually exhibit severe decay. For location of individual areas listed below refer to drawing 2.

1. North end timber D is not connected to the rear sill and is only supported by stone piers.
2. North end timber C is not connected to rear sill.
3. North end timber B is not connected to rear sill.
4. Timber B cracked through near joist L, but supported by stone pier.
5. Crack below tenon, south end of timber B, not adequately tied to sill.
6. Joist I-G is cut off flush with chimney and supported by a wooden prop (see photo 5).
- * 7. Area of south sill under west door is badly decayed (see photo 6).
8. Timber C is disconnected from south sill and is being supported by a pile of decayed firewood. This timber is not supported by either front or rear sill only by stone piers (see photo 7).
9. Stone pier, center timber C is not making contact.

10. Stone pier, timber D between joist I and J is tipping. Looks like its survival as a support is transitory.
11. South end of timber D is badly decayed. This timber is only being supported by stone piers and is not tied into the front or rear sill (see photo 8).

12. Sill E shows signs of past eastward movement. Dovetail at the juncture of timber D and joist G has partially pulled out. Two east/west steel tie rods have been installed to counter this. The tie rods are showing corrosion.

13. Timber E shows decay where it is making contact with curb stones.
14. East sill E at south sill juncture has separated.
15. There is decay below mortise at the juncture of the south sill and the west entry porch sill.

16. Joist P-B split below tenon at its juncture with west porch sill.
17. Decay below mortise at the juncture of porch south sill and its east sill.
18. Some Powder Post Beetle damage in timber E between joists J and M.

19. Various joists in Bays I, II, and III are supported by wooden props just resting on the ground.

1. Timbers were not properly connected when rear sills were installed. It requires the installation of custom fabricated steel hangers as seen in drawing 4. Care should be taken to determine whether rear sill condition provides adequate support. Rear sill is segmental. Individual segments do not appear to be connected sufficiently. All metal hangers should be properly treated to protect them from corrosion (paint, galvanized).
2. See No.1
3. See No.1

4. Because the crack in this timber is supported by a stone pier the danger of downward deflection has been abridged. Therefore this support should remain in situ. Parallel flooring has reduced the potential of lateral movement. However the installation of a steel reinforcement would prohibit lateral separation.

5. Installation of steel timber hanger is required (see No. 1). Extra care should be used to assure split is arrested.
6. Much of the load here is transferred via the flooring to adjacent joists. However as the wooden prop decays downward movement can be anticipated. Due to the proximity of end grains to masonry, joist area should be treated with a preservative and secured with a custom hanger to the masonry. If condition of the mortar prohibits this installation a pressure treated prop at the west end will probably suffice.

- * 7. Several options for repair exist here. Several feet of the decayed sill can be removed and replacement timber can be spliced into its place. If the areas removed support studs these studs should have ample support while the repairs are

made. Thin exterior sections of this decayed area of timber are intact making consolidation with an epoxy resin conceivable. This method allows for the retention of more original fabric. The practical use of epoxy consolidation is dependent on the type and extent of decay.

8. See No. 1
9. This timber has adequate support from piers. The gap under the timber can be filled with a stone shim.
10. Timber should be temporarily supported while stones in defective pier are shimmed or relaid. Modern building practice calls for proper concrete footing. Under the circumstances installation of concrete footings under any of the masonry piers is unrealistic because of the height restrictions of the crawl space. The labor involved in the excavation and transport of materials would not equal the benefits gained. Considering the longevity of the existing stone piers the traditional building practice of "chinking" up gaps as necessary is recommended. If additional support is required more modern masonry piers can be added between existing stone piers.
11. Timber D is likely the most difficult timber in the crawl space to repair. Once again no one solution

is the correct one. The extent of the decay however makes consolidation impractical. Additional dimensional timber can be added to the sides and end of timber D and attached to south sill with conventional metal hangers. This built up timber patch requires less cutting, and individual segments are easier to maneuver within the confines of the crawl space. However depending on how much of the decayed fabric has to be cut back this treatment might not provide adequate structural strength.

Another technique would involve the addition of solid timber section carefully spliced onto the end of timber D. This treatment requires the cutting back of timber D, and removing the decayed section (drawing 8). This is stronger than the above laminated repair but might be impractical due to the size of the patch, nine by ten inches, and the location in the crawl space. Either repair may necessitate removal of enough flooring to gain access. Removal of the 20th Century tongue and groove flooring would greatly alter repair strategy in the crawl space. Since flooring is laid perpendicular to the underlying flooring, localized removal of the flooring is not viable. With the tongue and groove floor removed individual sections of earlier flooring can be removed effecting access to repair areas.

12. Recent movement of east sill was not detected. The condition of the steel ties should be monitored periodically or replaced with ones having a decay resistant finish.

13. Decay is not serious but condition behind chimney could not be determined. As work is in progress removal of the lower clapboards and sheathing for inspection is suggested. Topical application of a wood preservative from the exterior might arrest further decay.

15. This decay is limited but separation in exterior trim indicates it might be progressive. Epoxy consolidation would work here.
16. This split can be arrested by installing a steel hanger to the porches west sill.

17. From the interior this timber shows only minor decay. However saturated bottom clapboard covering it suggests an unseen problem. When these clapboards are removed for replacement the bottom sheathing board should also be removed and the timber repaired. Nature of the decay suggests epoxy consolidation.

19. Wooden props are used throughout the crawl space. Most make contact with just the soil below. Thus as props decay support value is negated. Also insects such as termites can travel through these props infesting the the timbers above. Prop removal is suggested. If extant joists exhibit insufficient support additional joists of dimensional lumber can be added between joists. Standard metal hangers can be used to attach new joists to timber.

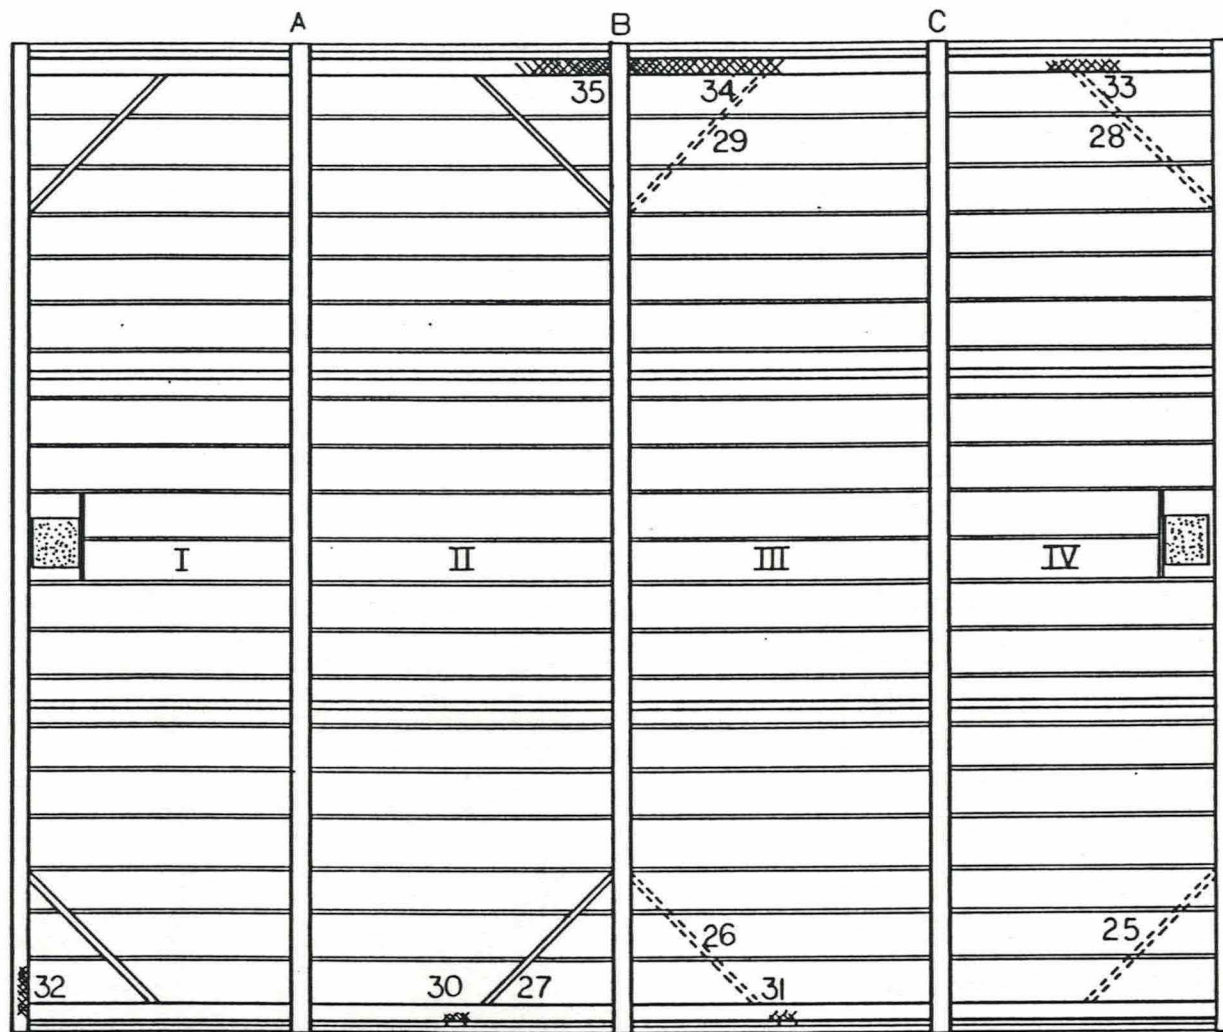
DRAWING 3: MEETINGHOUSE:
LOFT FLOOR FRAMING PLAN

Severe decay in the loft frame indicates many years of previous roof failure. Due to the installation of the new roof in 1990 the continued spread of decay has been arrested. Unfortunately some severely decayed framing members have completely lost

their structural integrity. Because of earlier decay in this area some of these structural elements were already removed, probably during the installation of the matchboard ceiling in the 1890's. Areas listed below can be located on drawing 3.

25. Diagonal brace connecting east plate and south primary plate is missing.
26. Diagonal brace connecting tie beam B and south plate Bay III is missing.
27. Diagonal brace connecting tie beam B and south primary plate has been cut at its juncture with plate, and has been toenailed to the top of the plate (see photo 10).
28. Diagonal brace connecting east plate and north primary plate Bay IV is missing.
29. Diagonal brace connecting tie beam B and north primary plate is missing.
30. South primary plate at porch west plate juncture Bay II is severely decayed.
31. South primary plate at porch east plate juncture Bay III shows decay.
32. Area of west plate, southern end shows advance decay (see photo 11).
33. North primary plate is severely decayed midway between tie beam C and east plate (see photo 12).

34. North primary plate is severely decayed midway between tie beam B and C.
35. North primary plate at its connection with tie beam B is so severely decayed it no longer exists (see photo 14). Compare to healthy plate in photo 13.

25. This diagonal brace probably has been missing for close to one hundred years, its indispensibility is in doubt. However since half of the corresponding loft's braces are also missing replacement would be preferred.

26. See No. 25
27. See No. 25
28. Similar to diagonal brace listed in number 25. This brace however should not be replaced until primary plate is repaired.

29. See No. 28
30. This area shows no movement at present. However, since two other connections that tie the entry porch to the main structure are also decayed installation of steel reinforcing rods would be recommended.

31. See No. 30
32. This timber has a deep decay pocket. Fortunately it is a timber of large dimension and therefore maintains its structural integrity. Epoxy consolidation is recommended.

the building. These studs and the upper section of the wall in Bay II are held in place by interior and exterior sheathing (drawing 8). The splicing in of new timber to reinforce the plate is recommended.

34. Location and severity of this decay requires the introduction of less material than in number 33. All material for splicing should be adequately seasoned. Similar wood species is preferred when possible.
35. See No. 34
36. Install treated threshold with at least a twelve degree slope. Threshold should extend under jambs to prevent intrusion of water. Caulk as necessary.
37. Move step stone southward one and one half inches to replace skirtboard with pressure treated material. Pitch top of the stone away from building to facilitate drainage.
38. See No. 37
39. Remove decayed clapboard and also lower sheathing board if necessary. Inspect and repair sill if needed. Install new treated sheathing and clapboards.
40. See No. 23
41. Install appropriate wood or metal drip cap, "lead coated copper" if preferred. The drip cap should tuck under adjacent clapboard.

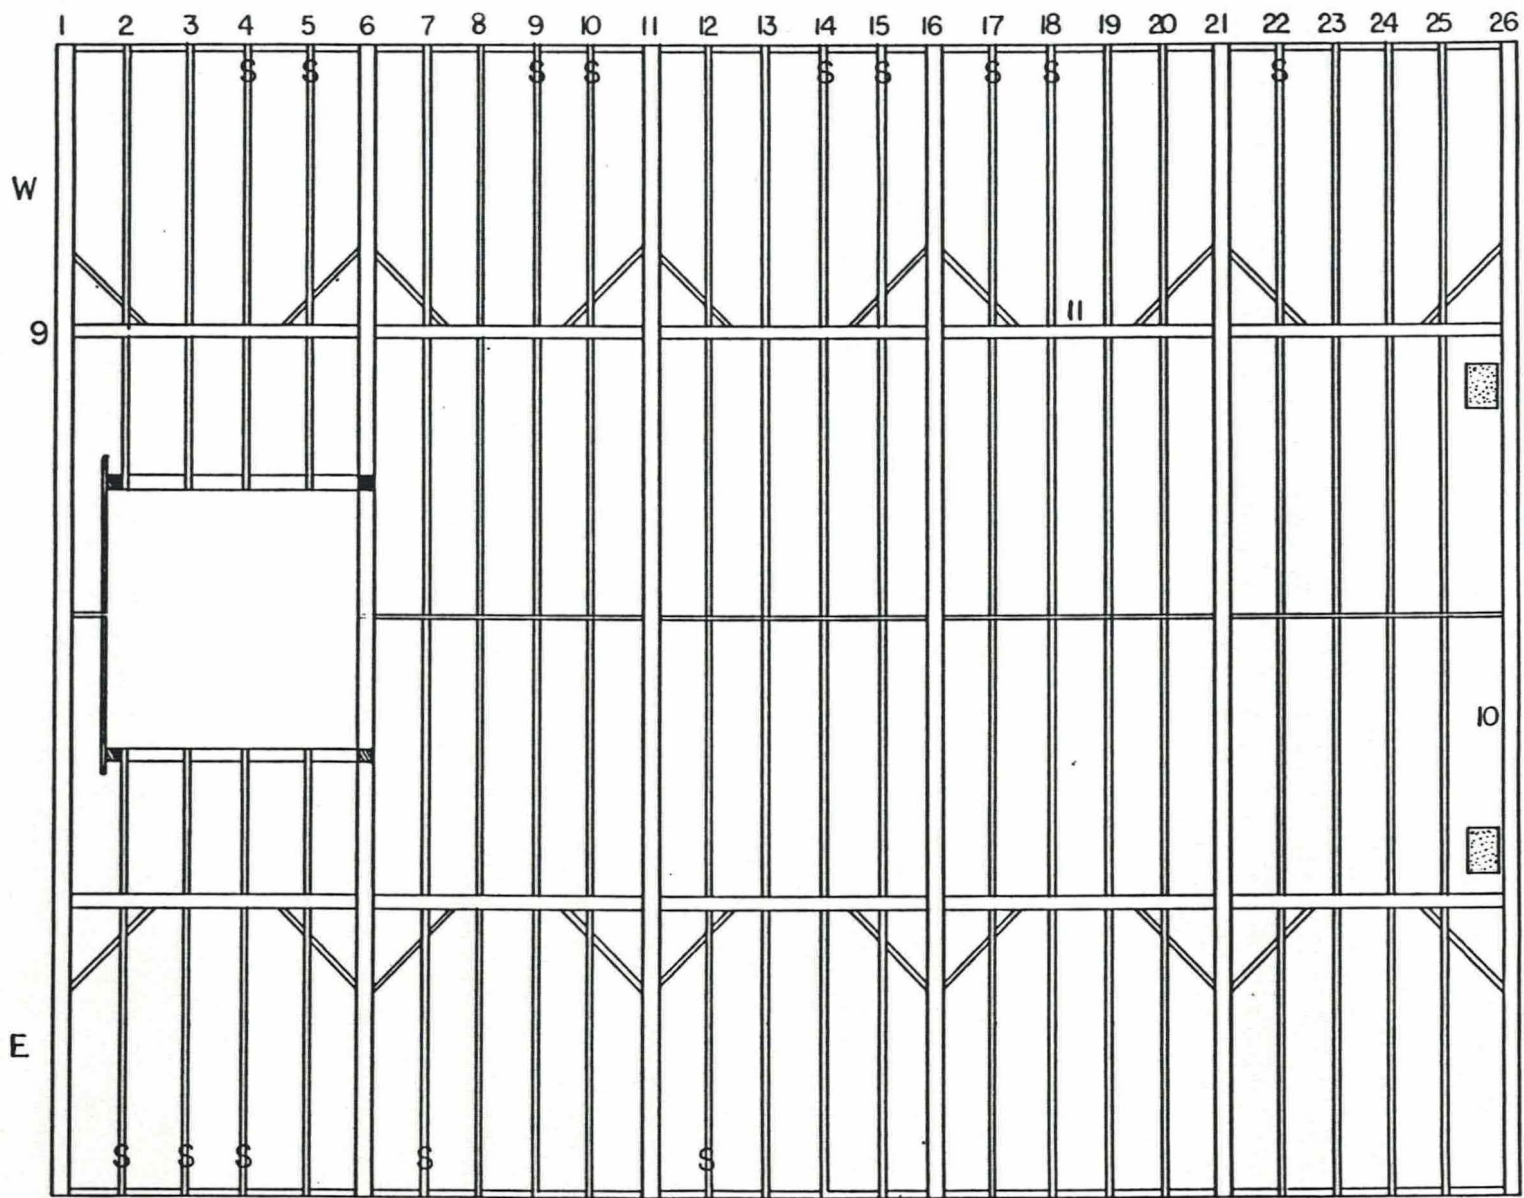
DRAWING 5. PELHAM CHURCH
ROOF FRAMING PLAN

- * 7. Split in rafter feet at W2, W3, W4, W5, W9, W10, W14, W15, W17, W18, W22 (see photo 20).
- * 8. Split in rafter feet at E2, E3, E4, E7, E12.
- 9. Split in principle rafter W1 at its juncture with purlin.
- 10. Split in principle rafter E26.
- 11. Fractured purlin between principle rafters W16 and W21 (see photo 22).

- * 12. Splice in east end of tie beam E has failed (see photo 18).
- 13. Splice in secondary plate northeast corner (see photo 21).
- 14. Split in east secondary plate at its juncture with tie beam B.
- 15. Split in east cradle supporting tower southeast side.
- 16. Tie beam E has a bad check in it.

6. Removal of homosote panels will increase air circulation. This will speed up drying after rain storms thus inhibiting the growth of fungi.
7. Although these splits are not of recent origin and are probably a result of the slate roof installation, their repair should be attended to. The simple installation of custom steel brackets bolted into the secondary plate will arrest further movement (see draw. 9). Since most rafters are of similar dimension bracket fabrication can be accomplished economically.

8. See No. 7.
9. Principle rafters can be reinforced top and bottom with steel plates. Steel plates to be connected with carriage bolts.
10. See No. 9.
11. This is an old break. It has been reinforced with a bolted on 4x6. The repair is working. But stress on principle rafter at purlin juncture suggests additional reinforcement. The steel clamps mentioned above will serve the purpose here.

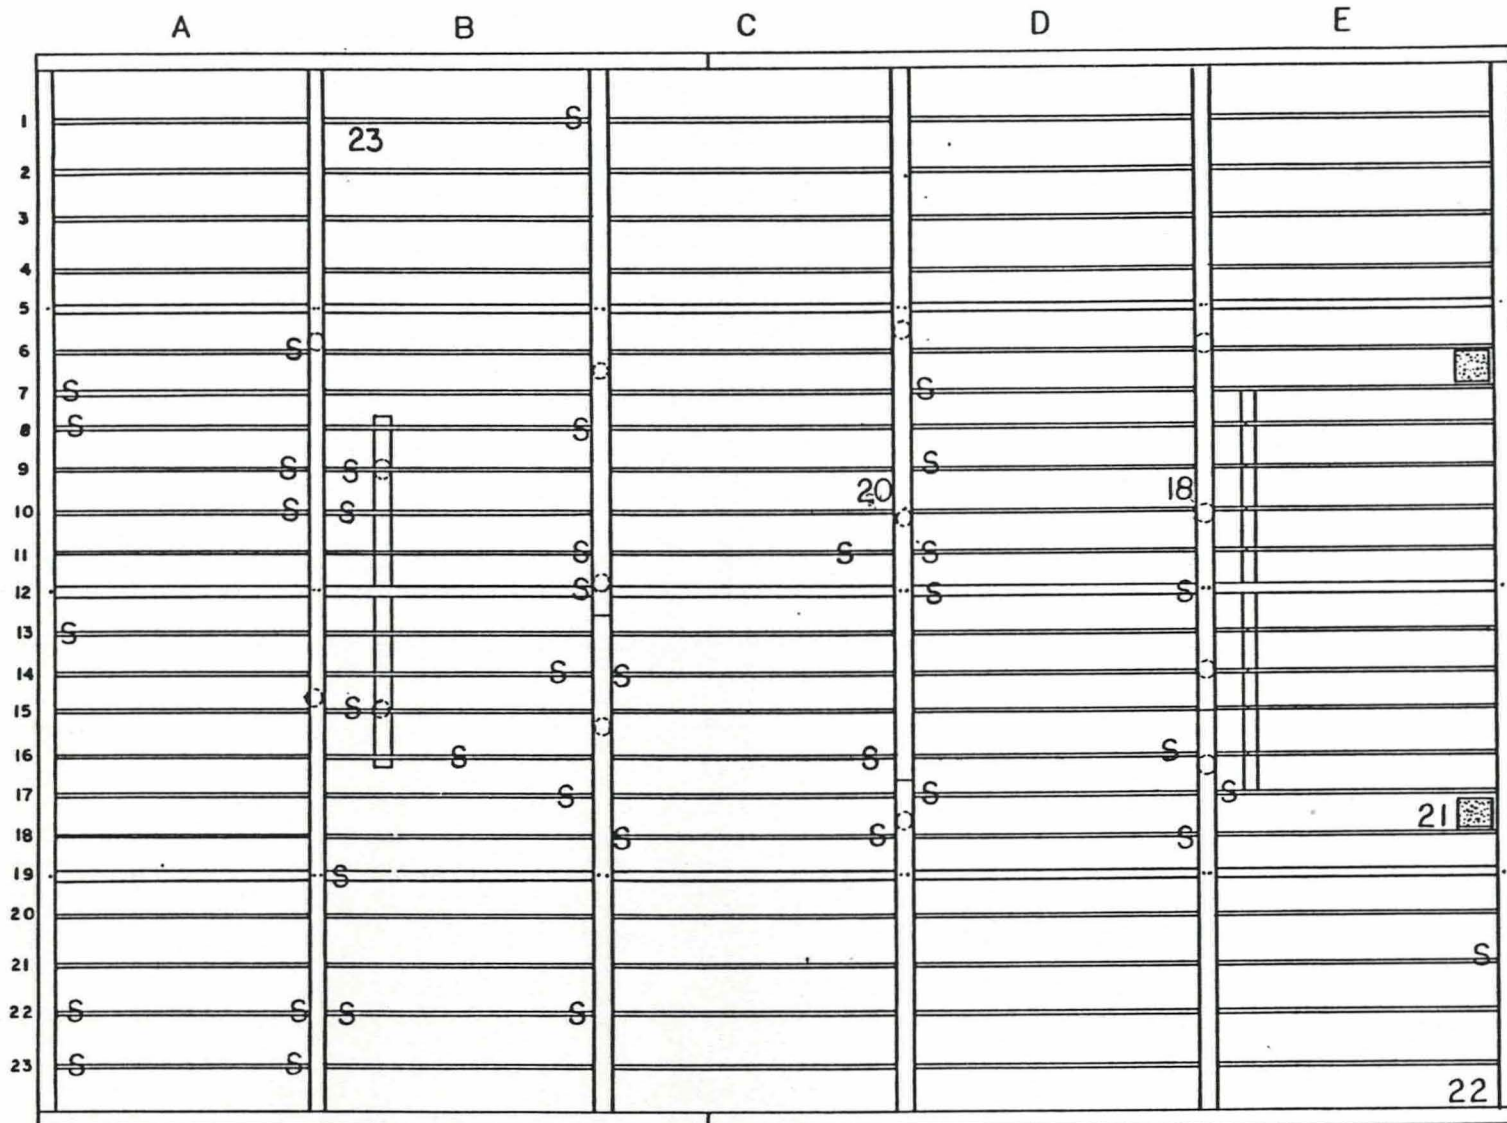
DRAWING 7: PELHAM CHURCH
FIRST FLOOR FRAMING PLAN

- 17. End split on joists A6, A7, A8, A9, A10, A13, A22, A23, B1, B8, B9, B10, B11, B12, B14, B15, B16, B17, B19, B22, C11, C14, C15, C16, C18, D7, D9, D11, D12, D16, D17, D18, E17, E21 (see photo 23).

18. Birch supporting column is infected with fungi. Fungi is spreading to superstructure.
19. Decay in west sill south end.
20. Column slipping off stone.
21. Decayed brick east chimney base.
22. Cracked north sill east end.
23. Some wooden farm implements are infested with wood beetles.
