**Pelham's Historic Town Center Buildings:
Study Reports**

Thomas Paske

This report was prepared for the Pelham Historical Society and the Pelham Historical Commission. The purpose of this survey is to describe the structures' present condition, locate damage and outline repair procedures.

April, 1991

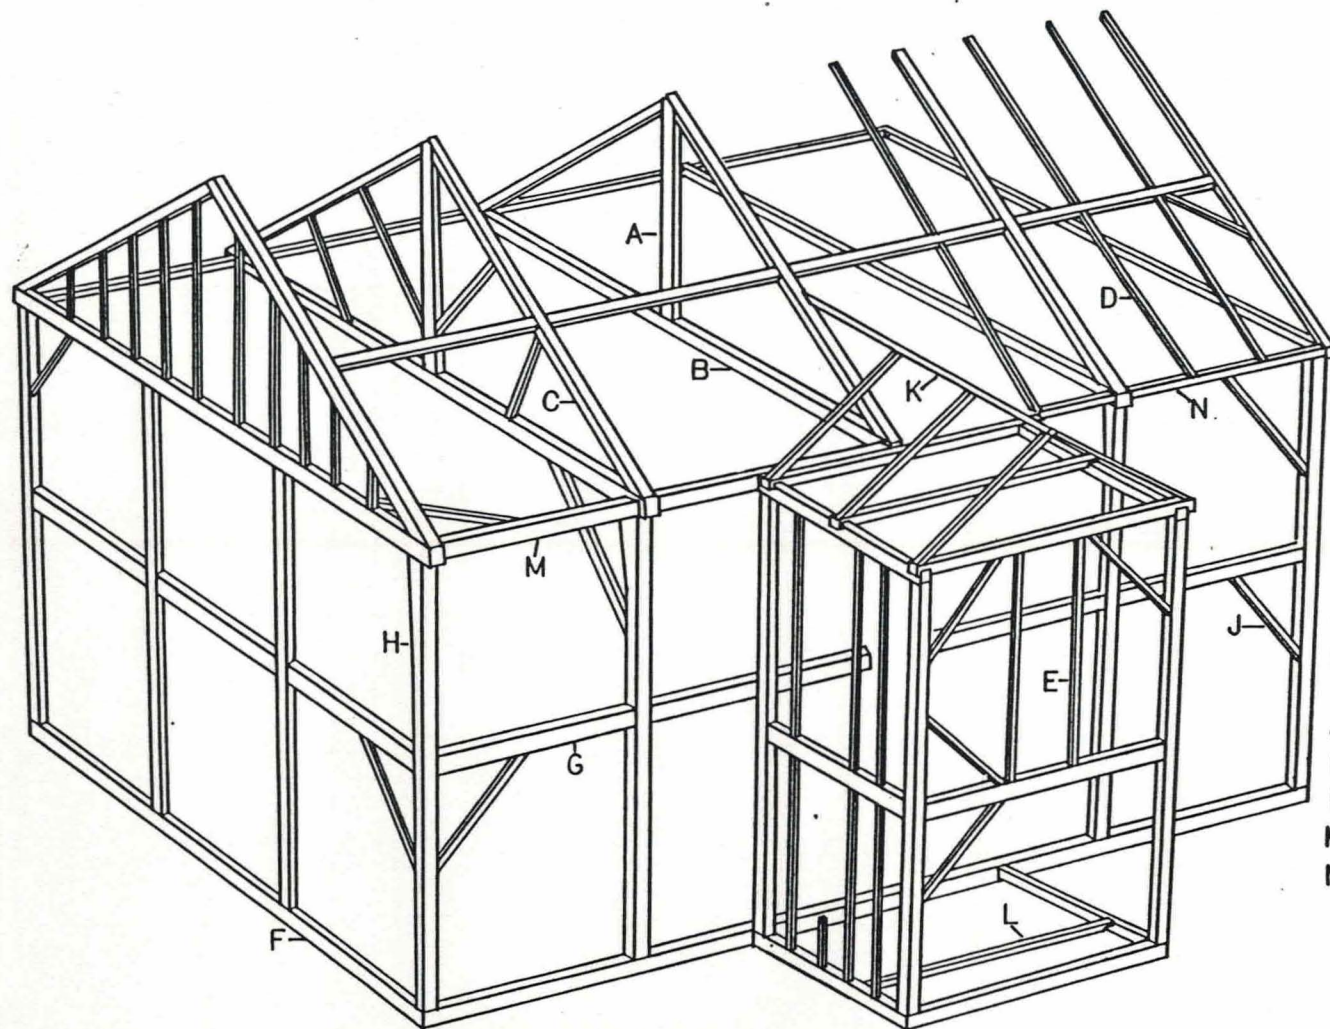
DRAWING I: PELHAM MEETINGHOUSE

The 1741 frame itself consists of (draw. 1) four bents, surmounted by five principal rafter trusses (photo 2). The center truss did not rest on posts; it is carried by the primary plate and stud wall below it. There is no ridge pole. Principal rafters are mortised into the kings posts. Secondary rafters are open mortised and pegged. Principal rafters are connected with separate purlins which in turn carry the secondary rafters. These secondary rafters consist of a lower rafter and an upper rafter both mortised into the purlin. The three central trusses consist of a tie beam, kings post, and two principal rafters braced both to the tie beam and kings post. The kings posts are mortised/half dove-tailed into the tie beam. Gable principal rafter sets have no kings post but are open mortised at the top and supported by 3"x 4" studs. King post and braces are not necessary because the end trusses are supported by medial posts, whereas the three center trusses span an open space. Each individual truss is connected with two purlins, two longitudinal braces, primary and secondary plate.

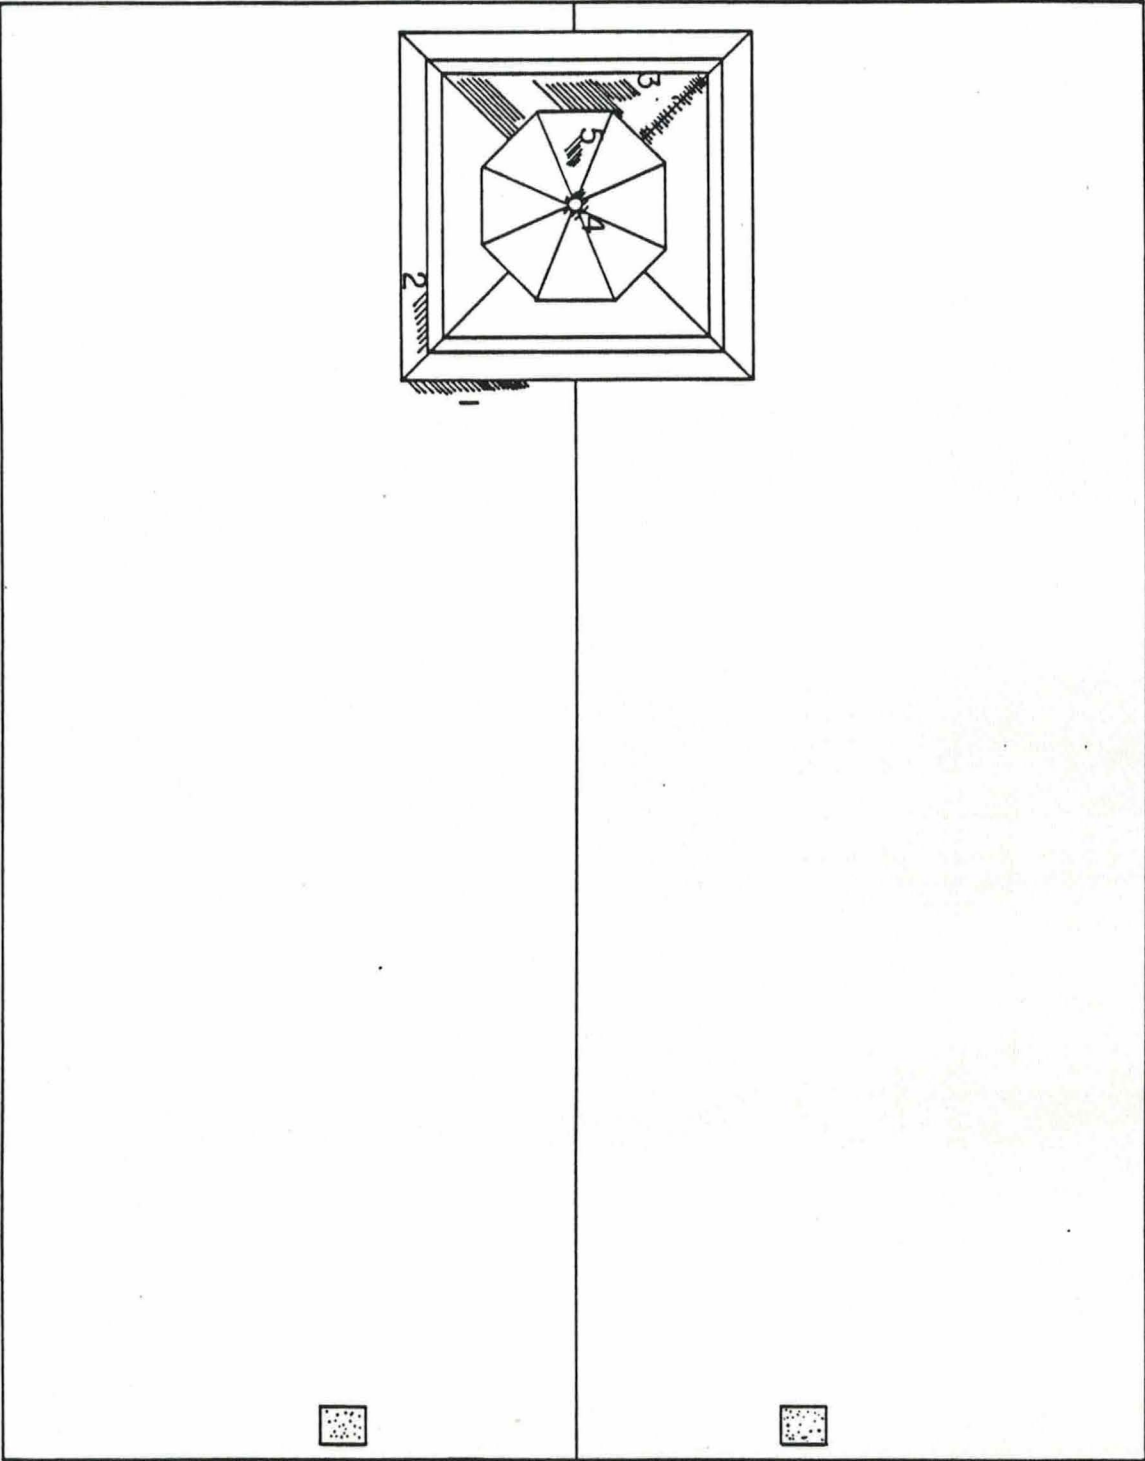
Refer to drawing No. 5.

- * 4. Steeple leaks at top.
- * 5. Steeple leaks midway on south side.
- 6. Homosote panel restricts ventilation.
